Continuous Visual Survey on Highway Br-010: Case Study on the Stretch between Estreito and Porto Franco – Ma.

Francyléia R. Brito, Rafaella O. G. Santos

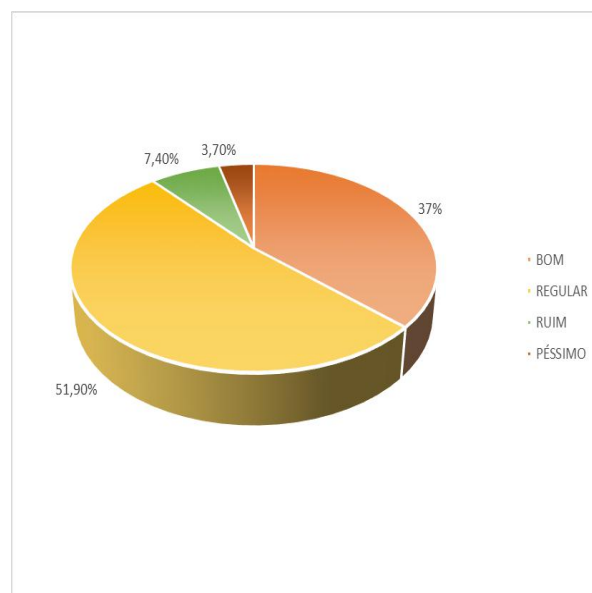
Fig. 2: Quality chart of the stretches

Figure 02 illustrates the results of the technicians' assessment of the sidewalk surface quality. Based on the application of the concepts presented in the graph, it was possible to establish the necessary corrective measures for each stretch. For the optimal concept, the DNIT (2003) standard suggests that only routine maintenance be done; on the analyzed road no section was found where this concept is applied.

In the graph it is possible to see that 37% of the analyzed stretch presents the good concept according to the application of the ICPF concept. The good concept

encompasses defects such as wear and tear, cracks that are not too serious in not very extensive areas.

The next concept is regular, present in 51.70% of the stretch. In this concept are defects such as potholes and patches.

The bad concept is present in 7.70% of the stretch, which includes defects such as surface or deep patches, in which case solutions such as resurfacing with previous corrections are indicated.

And finally, the application of the very poor concept occurred in only 3.70% of the stretch. This type of concept includes widespread defects and degradation of the coating and other layers; reconstruction of the stretch is suggested.
